Building Condition Assessment

Mechanical, Electrical, Structural, Building Envelope, & Site Elements

855 Main Street East
Hawkesbury, Ontario

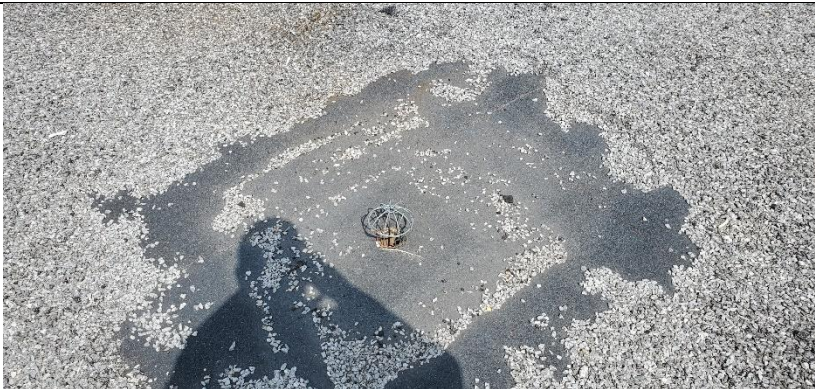
Photograph No. 3) Three of four roof drains need a proper cover.

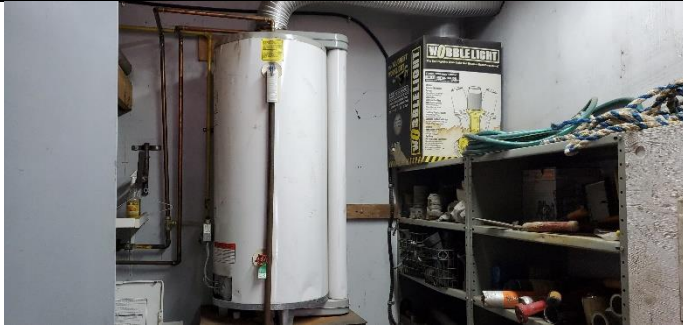
- c. The GSW hot water heater is past its life expectancy, however this unit may be able to keep working for another 5-years until the decommissioning of the building thus a replacement may not be required.

Photograph No. 5) "GSW" gas-fired hot water heater provided in the back shop area.

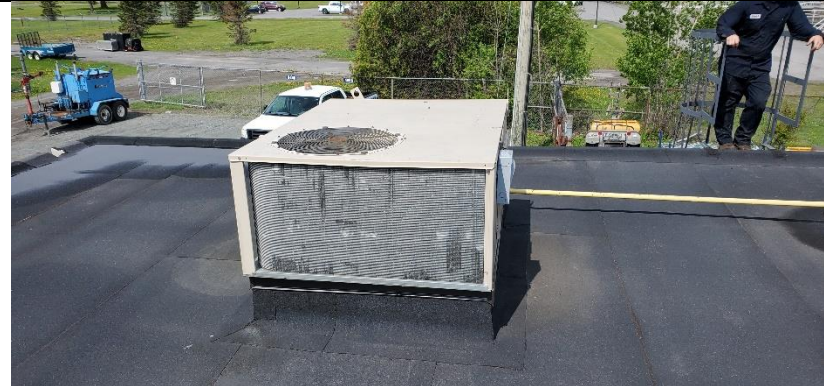
- c. The Lennox rooftop unit is past its life expectancy; however this unit may be able to keep working for another 5-years until the decommissioning of the building thus a replacement is not required.

Photograph No. 22) "Lennox" rooftop unit provided on the office roof.

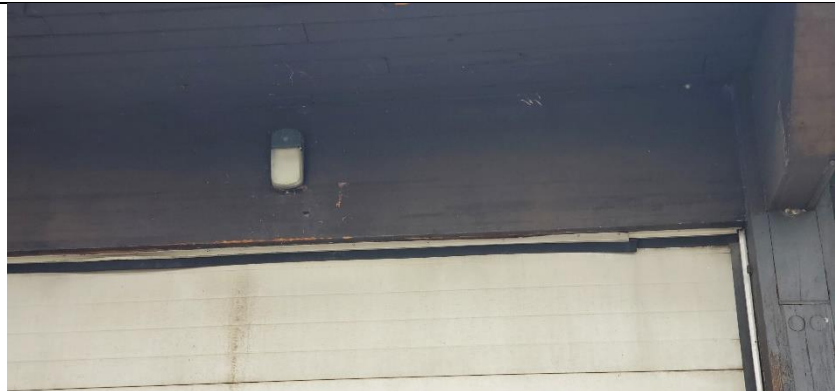
Photograph No. 32) Typical fluorescent wall mounted exterior light fixture provided on the perimeter of the office and garage building.

Table 2 Summary of Anticipated Costs – Lighting					
Item	Number of Units	Replacement Cost/Unit	Average Life Expectancy (years)	Estimated Replacement Year(s)	Total Replacement Cost
Exterior Wall Mounted Light Fixture	11	\$800	25	2022	\$8,800
Exit sign and emergency remote	*	\$500	20	2022	*

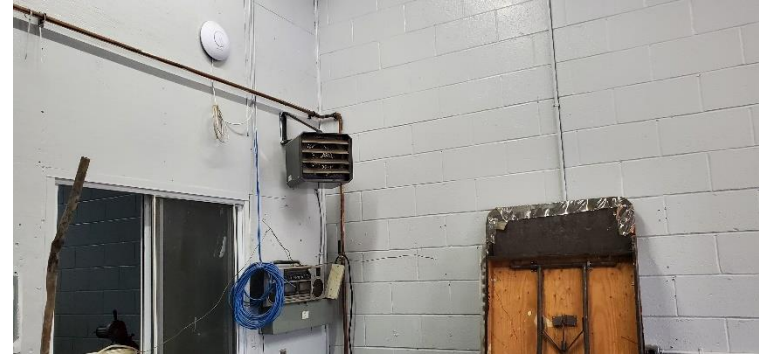
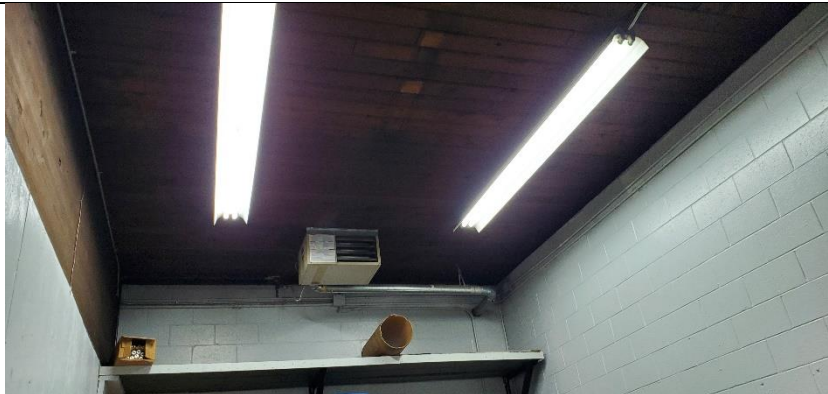
- a. Based on our visual inspection and review of record drawings, the electric heating systems appear to be operating as intended and no deficiencies were noticed.
- b. It was mentioned by operational staff on site that the unit heaters provided in the East storage area should be replaced for higher capacity unit heaters since the current heating load is not sufficient.

Photograph No. 42) Electric unit heater provided in the east garage area. Unit to be replaced due to low heating capacity.

Photograph No. 43) Electric unit heater provided in the east garage area. Unit to be replaced due to low heating capacity.

Table 3 Summary of Anticipated Costs – Electric Heating Items					
Item	Number of Units	Replacement Cost/Unit	Average Life Expectancy (years)	Estimated Replacement Year(s)	Total Replacement Cost
Electric Unit Heater East Garage Area	2	\$1,500	20	2022	\$3,000

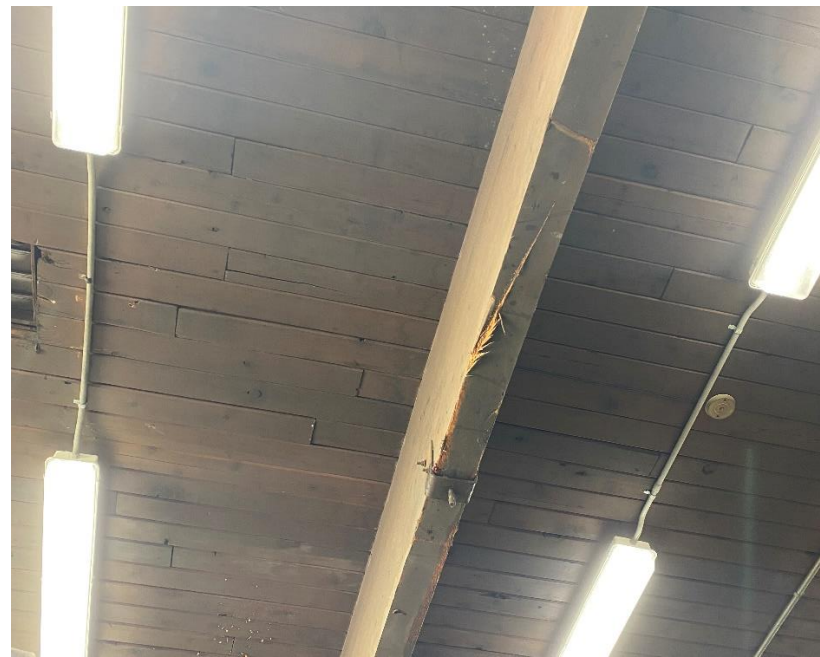
- b. Overall, the condition of the roof of the garage is good. There are several locations where it appears that equipment has hit the beams and minor scrapes remain.

Photograph No. 47) Typical damage to the deep glulam beams from equipment strikes.

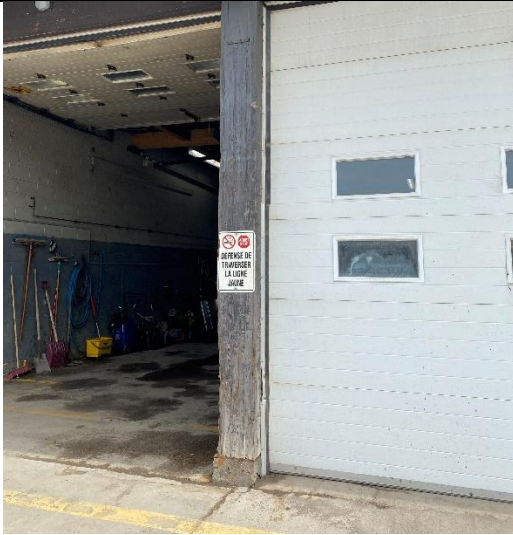
- c. The wood columns supporting the deep glulam beams at the front of the garage are in poor condition. It's apparent that with the heavy traffic of equipment going in and out of the garage, equipment has struck the columns several times. Protections should be undertaken to avoid further damage of these columns which could cause a collapse of the roof.

Photograph No. 48) Typical wood column supporting deep roof beam with damage.

- We suggest that you focus on critical/life safety issues that could result in collapse of part of the structure. This includes the wood columns at the front of the garage, and the damage and cracking in the CMU walls. We suggest:
 - Protecting the wood columns with steel plate armoring, and implement training and visual cues to reduce the risk of further strikes from equipment.
 - The damaged sections of the CMU wall at the back of the garage should be repaired.

Table 4 Summary of Anticipated Costs – SuperStructure					
Item	Number of Units	Replacement Cost/Unit	Average Life Expectancy (years)	Estimated Replacement Year(s)	Total Replacement Cost
Wood Column Armoring	6	\$1,750	20	2022	\$10,500
Repair Damaged CMU Wall	2	\$2,500	40	2022	\$5,000

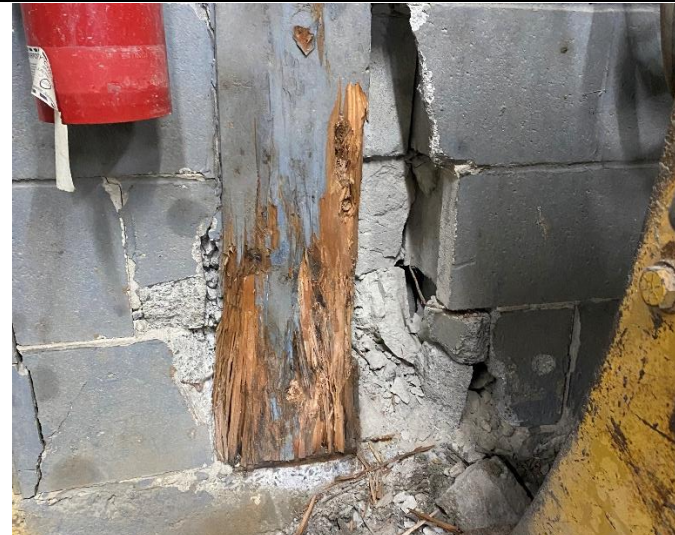
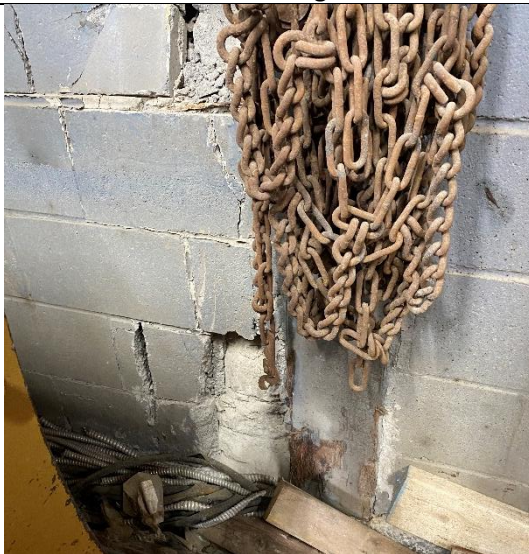
- d. The CMU walls of the garage have also been damaged. There are two locations of damage at the back of the garage where equipment has struck. These areas should be repaired.

Photograph No. 49) Damage to CMU wall at back of garage.

Photograph No. 50) Damage to CMU wall at back of garage.

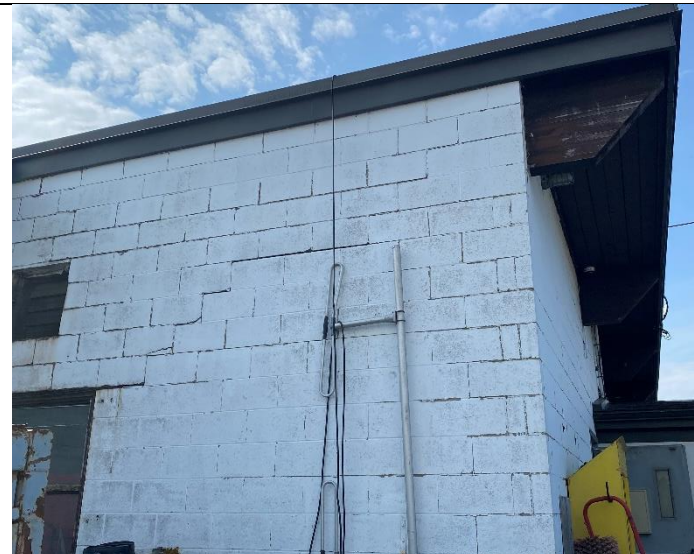
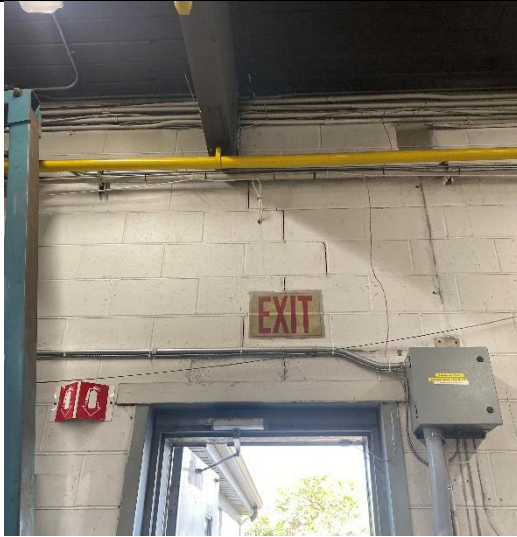
- e. There is significant step cracking in the CMU walls, specifically at the North-West corner of the garage. There are cracks on the North wall, and on the West wall extending from below where a beam bears, overtop of a doorway opening. These cracks should be monitored on a continuing basis for any widening. These walls will likely be very susceptible to any seismic activity.

Photograph No. 51) Step cracking in CMU wall at North-West corner.

Photograph No. 52) Step cracking in CMU wall below beam support.

- Monitor the cracks in the CMU walls at monthly intervals, taking measurements to determine if the cracks are widening. We can be of assistance in setting up crack monitors, recording and analyzing the data, should this be of interest to you.

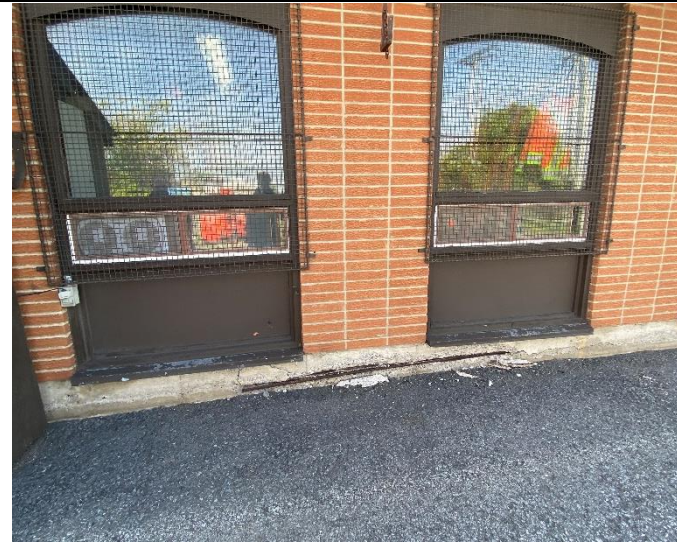
- f. Compared to the garage section, the North and office additions appear to be in much better condition. No significant cracks in the CMU walls were observed. A section of exposed rebar was visible on the West side of the office addition foundation wall. We do not suggest any repairs at this time.

Photograph No. 53) Location of exposed rebar in top of foundation wall of the office addition.

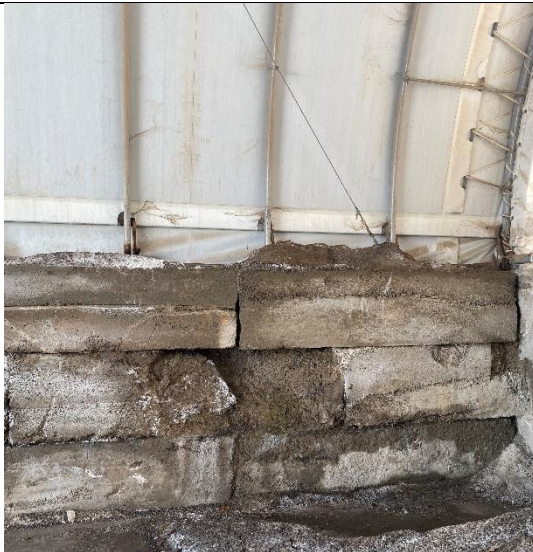
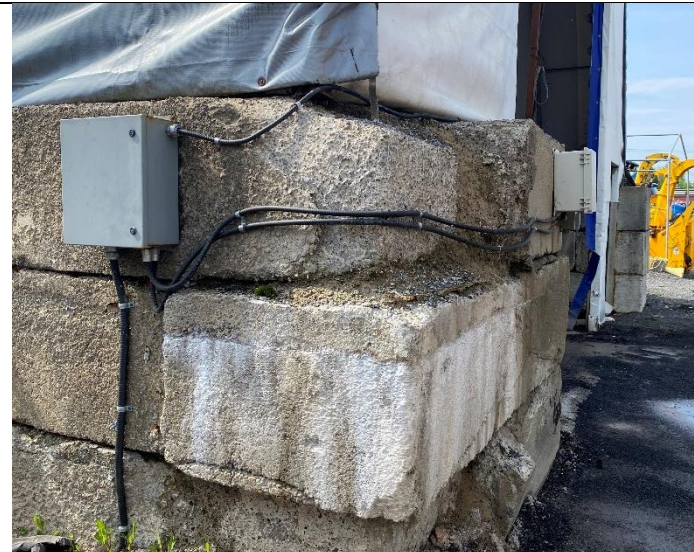
- As would be expected of a salt containing structure, the curved salt dome is deteriorated. The bottom of the curved frames are rusting. The inside of the concrete blocks are deteriorating, crumbling and becoming soft. Both conditions will only progress and continue to lower the strength of the structure.

Photograph No. 54) Typical deterioration of the salt dome frames and foundation.

Photograph No. 55) Typical deterioration of the salt dome concrete blocks.

- Carrying out repairs or replacement of the salt dome and enclosure would not make sense given the short time frame that this site will continue to operate. We suggest implementing advanced safety practices to mitigate the risks should a collapse occur. These should include:

- Monitoring the enclosures for significant progression of the deterioration
 - Restricting access to the interior of both structures to be only when a worker is inside of a fully enclosed loader.

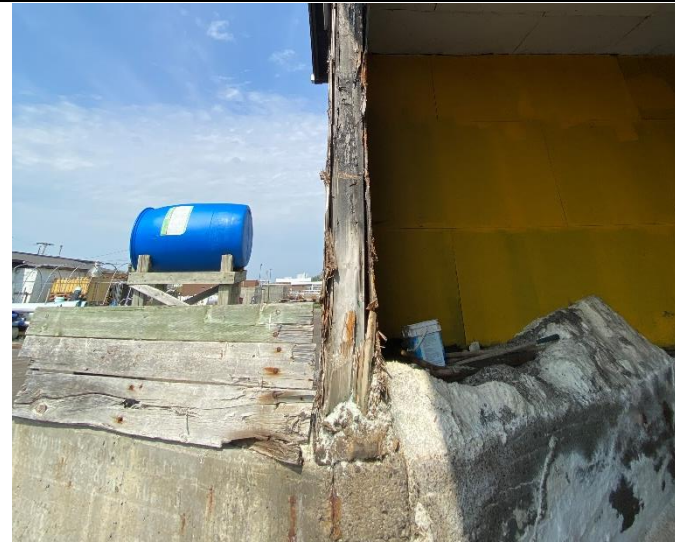
- The wood salt enclosure is in similar condition. Walls are bowing out to the exterior due to the pressure of salt and the force of a loader driving into the enclosure to load salt. We expect this deterioration to progress as well.

Photograph No. 57) Typical condition of the framing of the salt shed.

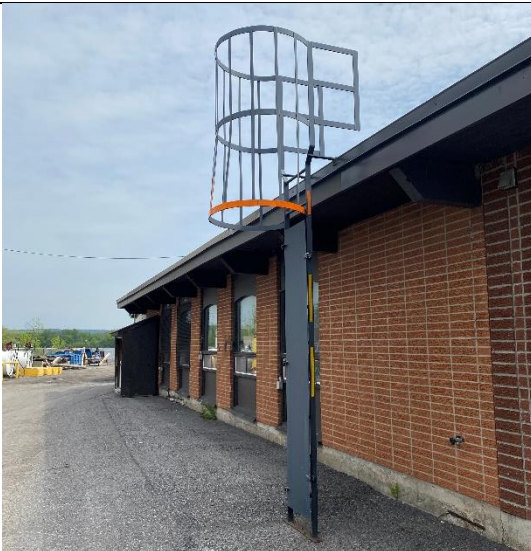
- a. The pavement around the building was in moderate to good condition. The pavement appears to be well graded to direct water away from the garage and addition and does not have significant cracking or pot holes. We do not suggest any investment and expect it to have a service life in excess of 5 years.

Photograph No. 58) Roof access ladder on the office addition, the condition of the pavement can be seen beyond.

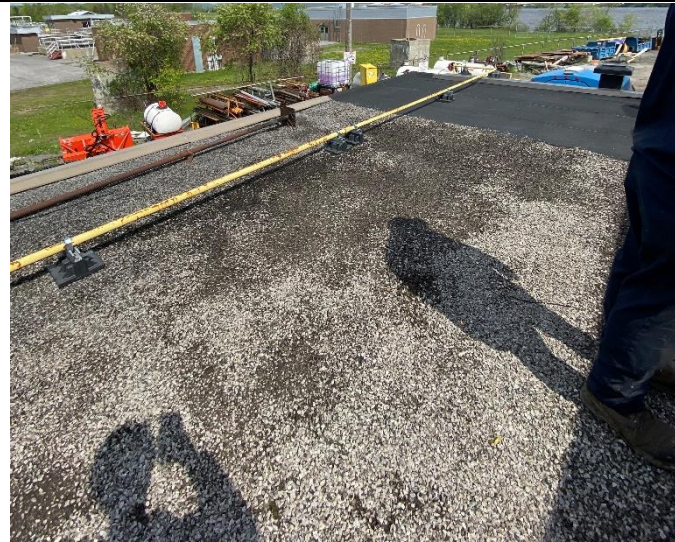
- a. Apart from the leaks in the roof described to us, the roof appears to be in good condition. Leaks should be patched as they appear applying minimal effort.
- b. The brick veneer of the office addition is in good condition.
- c. The doors and windows are generally in poor condition, however no action should be taken as they should still have service life to fulfill the next 5 years.
- d. As far as we understand, all overhead doors still operate. And although they do not fully meet the requirements of modern-day equipment, it would not make economic sense to replace them.

Photograph No. 61) Typical condition of the roof.
