September 29, 2017  
Project No. 18021

**Re: Maison de L'Ile, Hawkesbury, Ontario**  
**Masonry Walls Condition – Summary Letter**

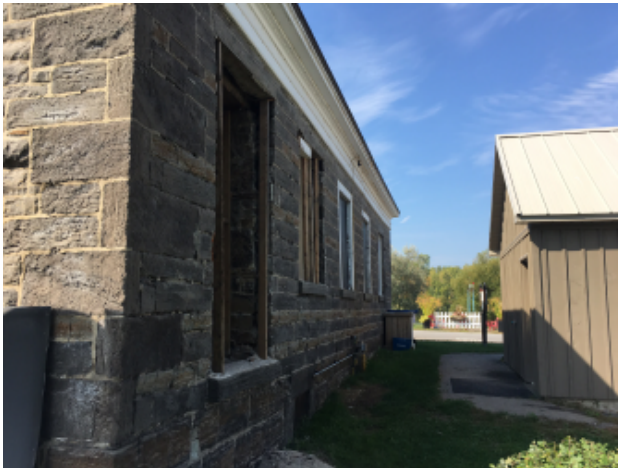
**Photograph No. 1:** North wall – looking west [JCAL 2017]

The north wall is in poor condition. There is visible bowing in the wall – a concave bow on the east half of the wall, with a convex bow on the west half of the wall. At the west end of the wall, where a door frame and window frame have been removed, there is visible separation of the inner wythe and exterior wythe, with the inner core reduced to essentially sand, with literally a pile of sand coming out of the wall from the mortar joints. This means the structural integrity of the wall is reduced, as the wall no longer acts as one massive wall, but two separate, more slender walls. Both these openings have been temporarily shored.

- North wall scope of work, to be done this fall/winter, in conjunction with on-going renovation project. Heating will be required in these Pilot Project areas, once the average ambient temperature is below 5 degrees Celsius, all materials are required to stay about 10 degrees Celsius.

- Remove plaster finish on the back of this wall (for the portion of wall, where the patio is located)
  - Pilot Project #1a: Take down and rebuild exterior wythe for portion of wall to west of existing door opening, under the direction of a trained professional engineer and experienced mason.

- Pilot Project #1b: Hydrovac sand and loose mortar out of wall. Once clear, grout wall for portion of wall to east of existing door opening. Monitor if grout leaks out onto patio area – as this may be an issue if grouting is to be considered for walls around the building where one side is finished with plaster. This should also be done under the direction of a trained professional and an experienced mason.

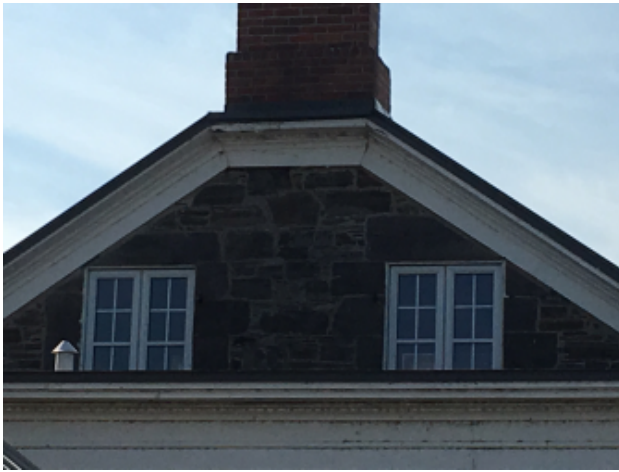
**Photograph No. 2:** North wall gable (original building)  
[JCAL 2017]

The north gable wall has no obvious signs of failure, like the south gable wall does (see photo No.9 for comments on the south gable). However it is considered to be in the same condition as the rest of the walls around the perimeter, and may be worse.

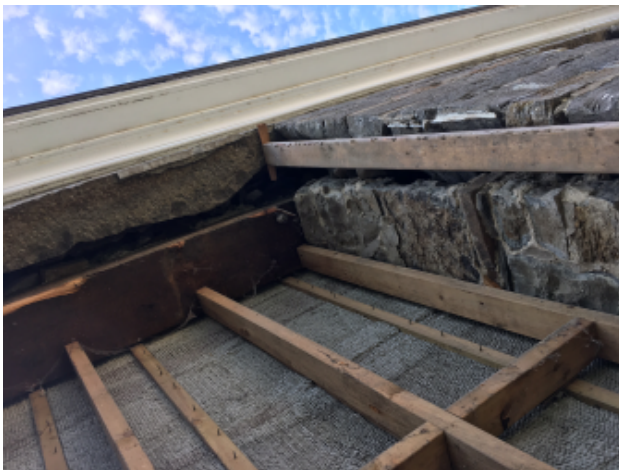
**Photograph No. 3:** North Wall, Existing Door Opening – looking up at the lintel [JCAL 2017]

At the existing door opening, a large timber lintel and a stone lintel create the opening. It was noted that the stone lintel has very little bearing at the end west end. The original door frame, like the three window frames along this wall, was likely a large timber frame which provided some support to the lintels. To the right of the photo, the exterior wythe of stone (behind the 2x4 shoring post) has separated from the inner wythe of stone.

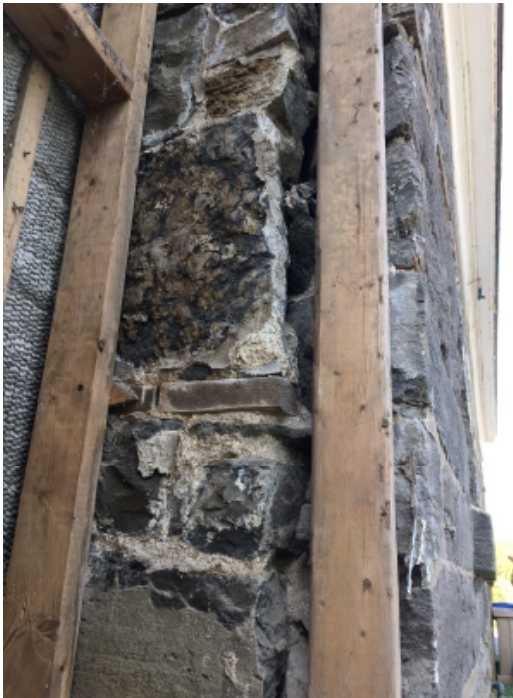
**Photograph No. 4:** North wall, door opening – west side of opening [JCAL 2017]

This photo is a close up of the west side of the door opening, the gap between wythes is to the left of the 2x4 wood shoring post. Very little to no bond is present between the core of the wall and the inner and outer wythes. This means the wall no longer acts as one massive masonry wall, it is effectively two separate, more slender walls, which reduces its strength capacity and causing the wall to bow as noted above.

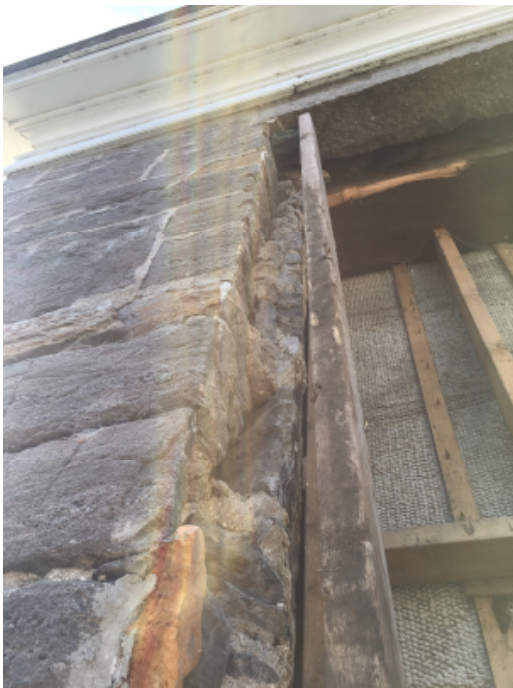
**Photograph No. 5:** North wall, door opening – east side of opening. [JCAL 2017]

The east side of the door opening has not separated. The mortar in the joints continues to be sand, for the most part.

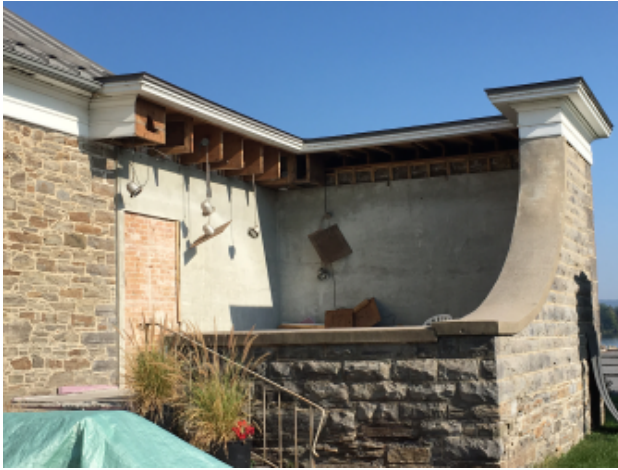
**Photograph No. 6:** North East corner of building  
[JCAL 2017]

The renovation project, calls for a new roof over this existing patio area. Part of this report scope is to define whether the sloped masonry wall is capable of supporting the new roof load. This sloped wall appears to sit on top of an existing masonry foundation wall. The masonry walls surrounding this patio are covered in plaster on metal lath, which has cracked in several different directions. This cracking may be an indication of movement of the masonry wall behind. The masonry exposed above the plaster is in fair to poor condition with many cracked or opening joints.

The brick wall (where the new door opening will be made) along the ground floor level is spalled and has deteriorated mortar.

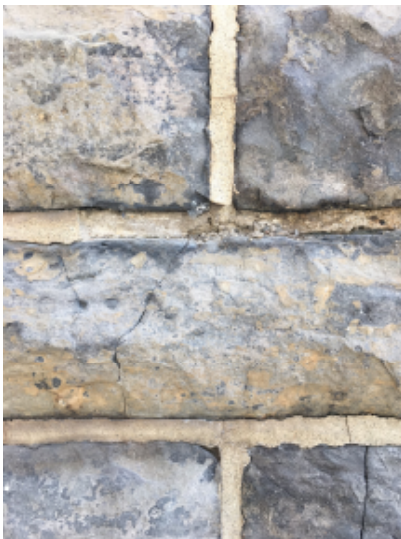
**Photograph No. 7:** Exterior side of the sloped patio

For the sloped patio wall, on the exterior face (the side of the wall facing the bridge), there is typically a thin layer of finishpointing mortar, over some small crushed stones – almost like mini pea stone – and then very soft mortar/sand behind. There is moisture in the wall behind the finishpointing. All finishpointing is in various stages of cracking and debonding from the wall. Some of the stones are fractured.

On the interior face of the wall, the mortar is an extremely hard cementitious mortar however, it is debonded entirely from the surrounding stones.

- Sloped patio wall, two stones will to be removed (one on each side) for further inspection/investigation.
- A long term rehabilitation plan should be developed based on the results of the north wall pilot project. All of the exterior walls of the building should be restored within the next 10 years, in order of priority: north wall, south wall, west wall, and east wall. Any budgeting or costing could be done after the pilot project is complete, as then we'll have a better idea how the restoration work will be complete and the full scope of the work.
- All vines should be removed from the masonry walls; they promote deterioration by holding moisture near the wall.

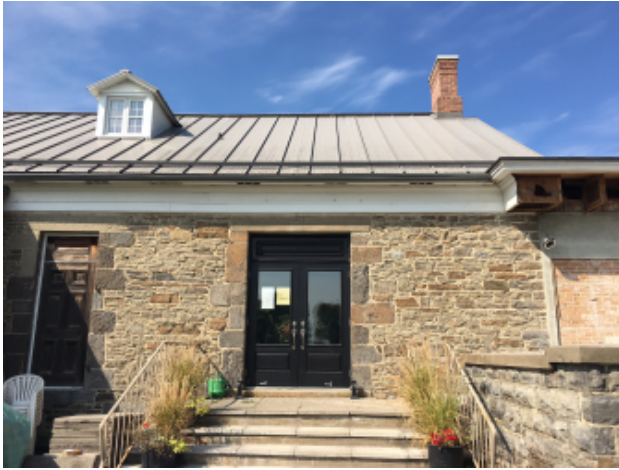
**Photograph No. 8:** Partial East Elevation  
[JCAL 2017]

This elevation is pretty typical of the exterior masonry walls for the original building, with larger stones creating the window and door jambs and medium to small stone making up the rubble coursing on the sections of main walls. Finishpointing is very thin and feathered over very thin (approximately 10mm) mortar joints and stone edges to create the illusion of thicker mortar joints. Along this wall, mortar behind the first 12mm of mortar had deteriorated to sand.

On the entrance facades, typically larger stones were used than on the gable walls.

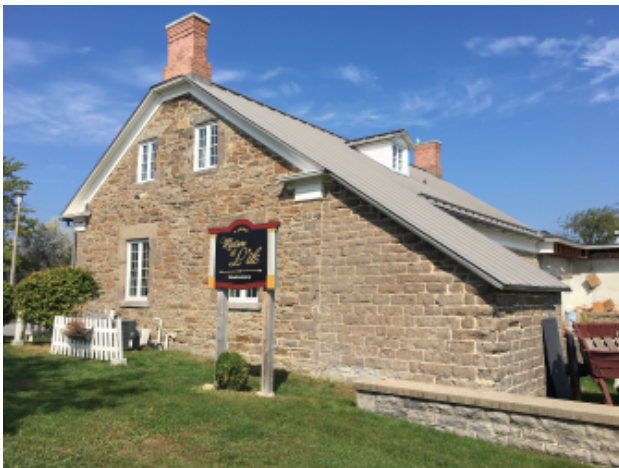
**Photograph No. 9:** South Elevation, original building  
and S.E. addition are evident in this photo [JCAL 2017]

The walls of the South East addition have a core that has reduced to sand. On the East wall of the original building, the gable portion of the wall has a significant bulge between the upper storey windows, with stones fractured and mortar joints open. This is a dangerous condition, as the wall between the windows isn't a solid masonry wall – as the flue for the chimney is likely built into the wall thickness, making this section of wall weaker structurally speaking. The section of wall at the ground floor level, is in poor to fair condition, some mortar joints had firm mortar in them but most had soft mortar or sand, behind the thin finishpointing layer that had been feather over the thin mortar joints.

- Cordon off the area below the south wall gable, so that no one can access this area of the grass. The exterior wythe of this gable wall is unstable and may collapse.

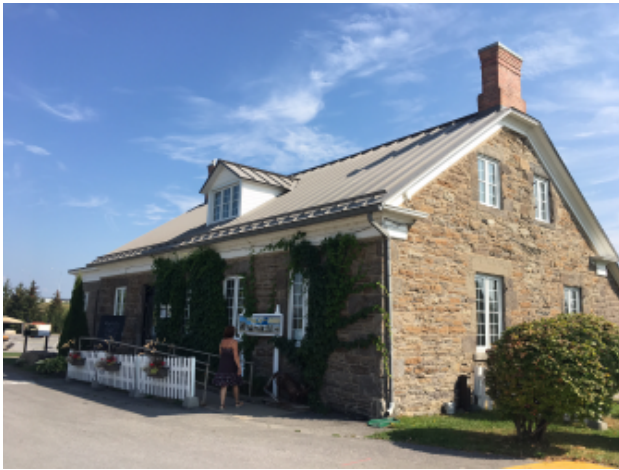
**Photograph No. 10:** South West side of the building  
[JCAL 2017]

Vines covered portions of the west elevation. North elevation is currently used as the main entrance to the building.

Both chimneys appear capped with no ventilation, causing moist air to accumulate in the flues and migrate into the stone promoting deterioration.

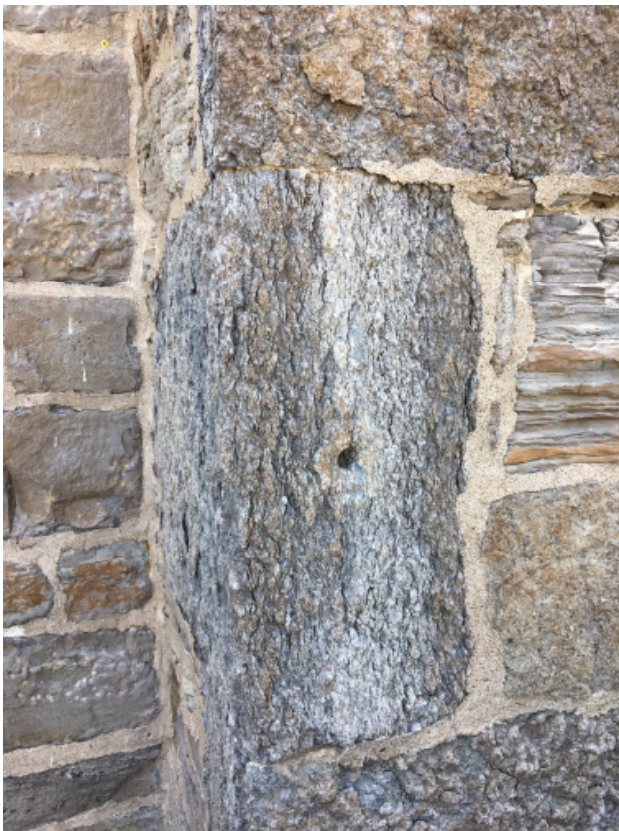
**Photograph No. 11:** Typical stones at corner of building  
and around windows and doors [JCAL 2017]

This is an example of extremely weathered stone at a corner of the building on the north elevation. The stone is delaminating and/or cleaving typically around the building. Any replacement stone should be of higher quality than this existing stone and naturally bedded. The bed seams in this stone are oriented vertically, they should be oriented horizontally.

The existing stone is a poor quality and likely will not hold up to a repointing program. Therefore, any budgeting for repointing that is done in the future, should include as much as 50% stone replacement. For stone sourcing, perhaps a granite from the Rock of Ages would be a good match for the window and door surround stones; for the main wall rubble stone, perhaps St-Canut sandstone (from St-Canut, Quebec) for the rubble stone with the red/brown colouring through the stone, and a Kingston Limestone (from Inverary, Ontario) or Champlain Limestone (from Havelock, Quebec) for the more solid grey rubble stone.

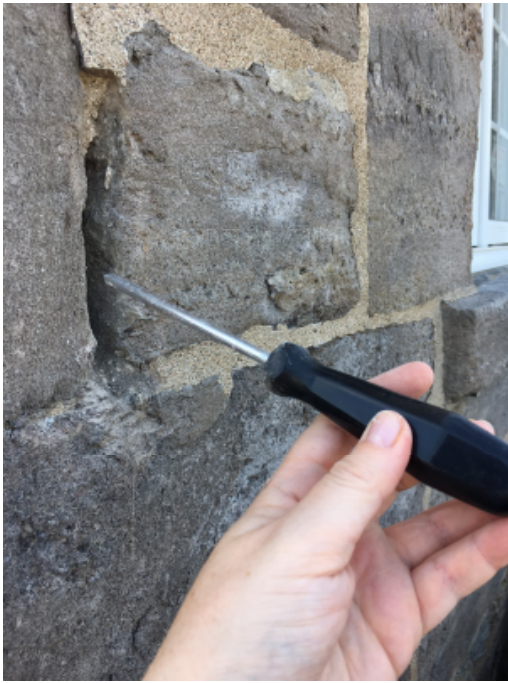
**Photograph No. 12:** Typical mortar joint (part 1)

This joint is located on the west elevation, however this is a typical scenario around the entire building.

Once the thin layer of finishpointing is removed, the mortar behind is sand. This photo was taken after the sand had fallen out of the wall – as evident by the completely void joint.

With the core of the wall reduced to sand, as stated earlier, this reduces the structural integrity of the wall, as it is no longer working as one whole massive masonry wall but two separate walls (ie. the inner wythe and the exterior wythe act separately).

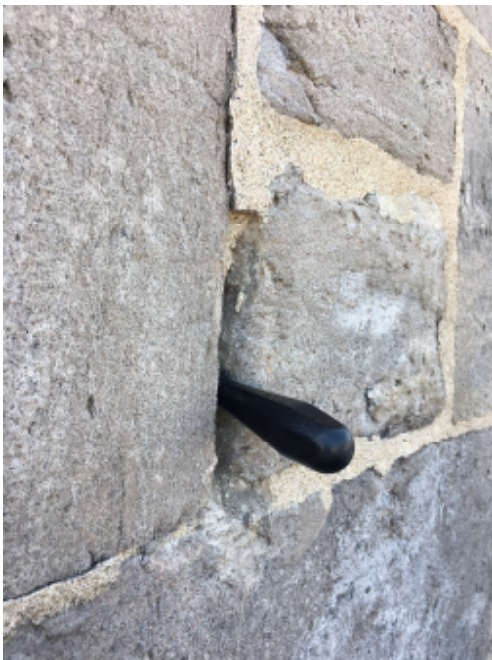
**Photograph No. 13:** Typical mortar joint (part 2)

My screwdriver extends easily into the wall, for it's full depth. If I had a longer screwdriver it would have gone in deeper.

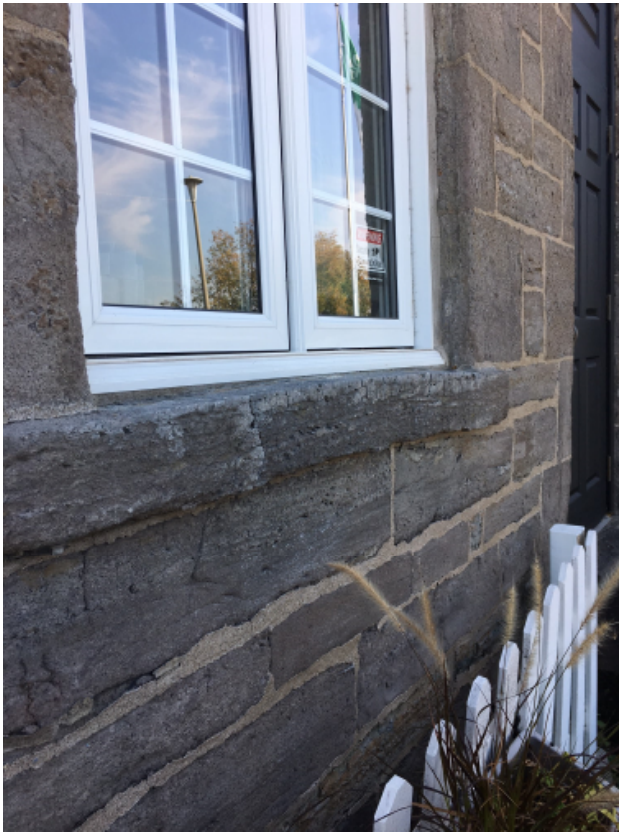
**Photograph No. 14:** West Elevation, window at far north end. [JCAL 2017]

The sill stone has an upward bulge to it, with the section of wall below the window bulging outward. The bulge upward has been there since the windows were installed, as the grout around the windows was installed to suit the slope.

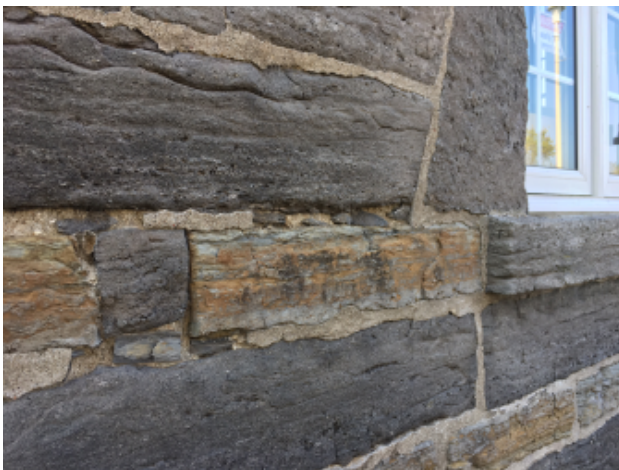
**Photograph No. 15:** Typical stone and mortar condition. [JCAL 2017]

The stone is generally in fair to poor condition. There are a lot of fractures or weathered veins in the stones, in multi directions. So, any rehabilitation of the walls will inevitably lead to a high amount of stone replacement, where raking out of the mortar joints is done.

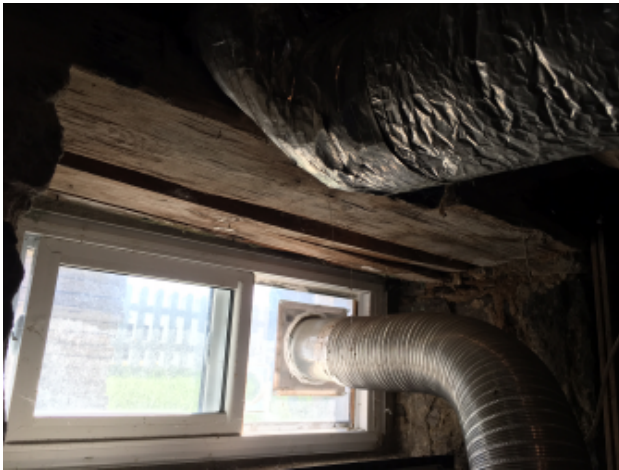
**Photograph No. 16:** Basement, east wall, southern window – north of basement entrance [JCAL 2017]

The existing timber lintel has split and dropped vertically by approximately 12mm. My screw driver could penetrate through the lintel without effort. This window lintel has not been shored. There is also a bulge in the masonry wall below this window, with open joints. Typically below basement windows, there is moisture in the mortar joints and the mortar is deteriorating, in fair to poor condition.

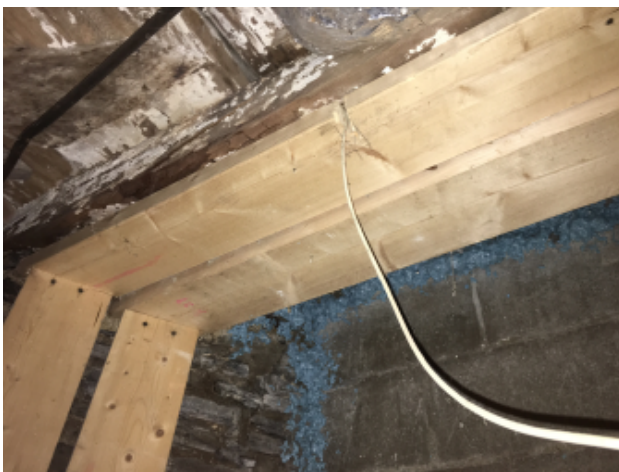
**Photograph No. 17:** Basement, east wall, northern window [JCAL 2017]

The existing timber lintel is rotten, and has been shored. There is a gap between the concrete block masonry infill at this window and the surrounding stone masonry.

Further south along this wall, the wood sill plate is in poor condition as well.
